Restoration Project
GLEAM TEAM – SALA DEL MAGGIOR CONSIGLIO
The gilding of the ceiling
Venice, Doge's Palace

Iconographic plan for the ceiling

Note on the conservation state

The restoration project

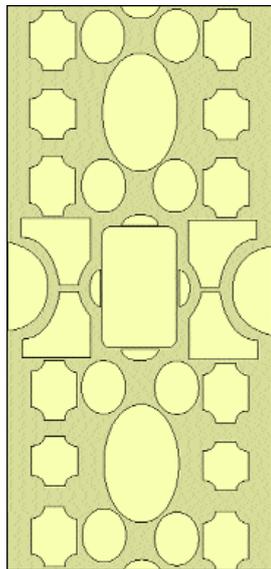
saw a procedure similar to previous circumstances (such as the pictorial decoration of the ceiling of the Scuola Grande di San Rocco): the wood decoration of the ceiling was designed and commissioned according to a plan that divided the space in simple and composite figures with different sizes and shapes: squares, rectangles, oval shapes, concave and convex crescents and so on. The wood

part – the frame – stretches along substantially regular axes, but the main backgrounds created this way are linked, tied and enlivened by a set of ribbons, swirls, shells, cartouches, whereas the external perimeter is supported by large modillions. This spiderweb of lines and shapes sees the superimposition of a further decoration enlivened by heads, allegoric figures, large symbols in a large and significant overhang that flows and concentrates especially on knots and crosses in the geometric structure.

The outline of the ceiling and below the wood decoration.

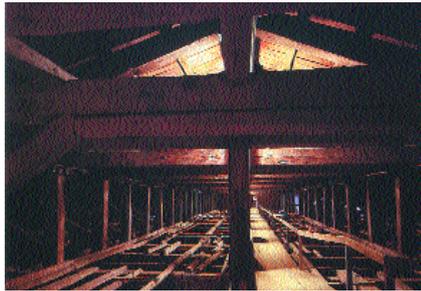
The garret of the Sala del Maggior Consiglio.

heavy weight. The engineering and carpentry tasks to provide solidity to the entire piece of work – to hang the paintings safely and to make the inspection and the maintenance from above viable – required special solutions to organisational and structural issues. Likewise, the garret had also to be ventilated so as to keep the temperature under control under the lead roofing.

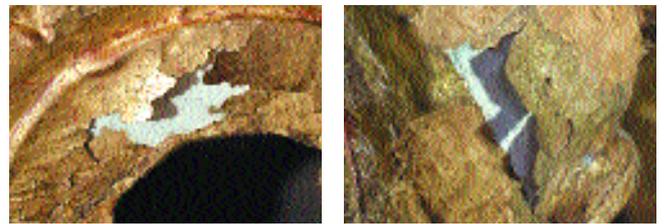
A close and thorough examination of the ceiling surface reveals the gilding is widely lifted, detached and disjointed

Details of the gilding detachment.

(preparation layers and gilts) in often large areas. In some points, the gilt fragments are slightly lifted, whereas in others the material is either unsteady or shaky and about to break off. Frequently, in correspondence of the disjointed areas, material parts fall down, as recent and past evidence demonstrates.

This deterioration is evenly spread with some variations in effects and extent and affects the entire surface of the wooden structure. It is visible along the whole of the geometric structure of the frames surrounding the paintings and on all the overhung decorations which are linked to or converge into it. It involves all the gilding, both the burnished and polished areas and the opaque, non-burnished ones, conceived to achieve light and shade effects, where the gilding is laid on a rough and grainy preparation. It also affects the most recent gilding, easily recognisable and probably made during the last restoration works of the ceiling.

There are many and concomitant causes for this deterioration state: first of all, given the proximity to the garret, the thermohygrometric changes in the

environment this large wooden structure is subjected to and reacts to; moreover, the humidity absorption probably caused by past rainwater leaks which left evident traces, and finally the methods used to make the gilding, where the plastering forms a thick and rigid preparation layer which is not very suitable to tolerate the changes in the substratum and in the environment.

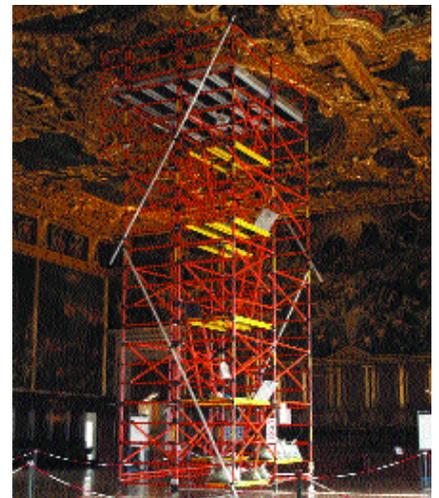
Scaffolding for the restoration work.

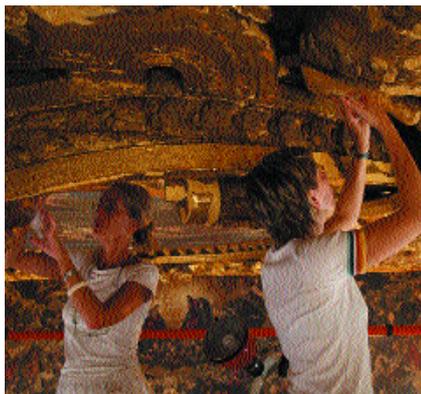
Restorers at work.

The operations carried out are microinjections under the detached leaves with Primal B67 with a 5-10% concentration depending on the size and the thickness of the detachments. To allow a better penetration of the consolidating material, its application is

After a suitable solidification time – which may be five minutes, so that the consolidating material can penetrate gradually and deeply – the leaves are lowered and reattached by pressing lightly cotton pads. Subsequently the Japanese paper veil is removed, if applied, as well as the residual consolidating material, by using moist pads containing water and alcohol.

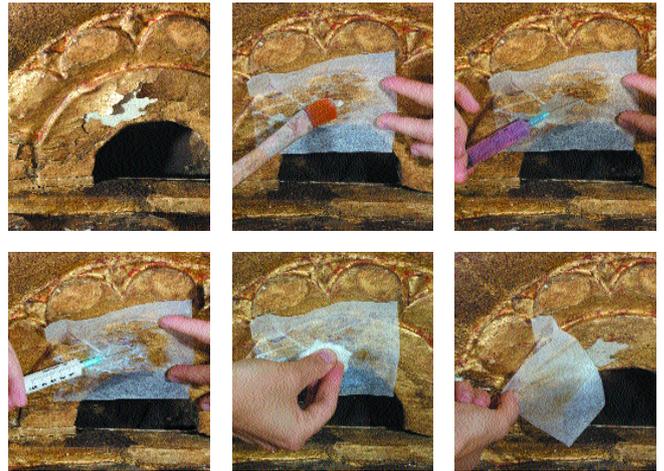
The various phases of the restoration work. Left to right, above to below: the detached gilding, the Japanese paper veiling, microinjection with water and alcohol, microinjection with acrylic glue, the cotton padding, the veil removal. Below, the wooden piece after the restoration and the watercolour adjustment of the colour nuances.

always preceded by microinjections of water and alcohol (1:1). These operations take place after protecting the detached parts with a veil of Japanese paper whenever parts of gold leaf risk to break off and fall.
